Historic Bridge Alternatives Analysis

BRIDGE NUMBER: (933)31-71-03690 E

ROUTE IDENTIFICATION AND FEATURE CROSSED:
SR 933 over St. Joseph River

PREPARED BY: Adam Steury, PE, SE
Lochmueller Group, Inc.

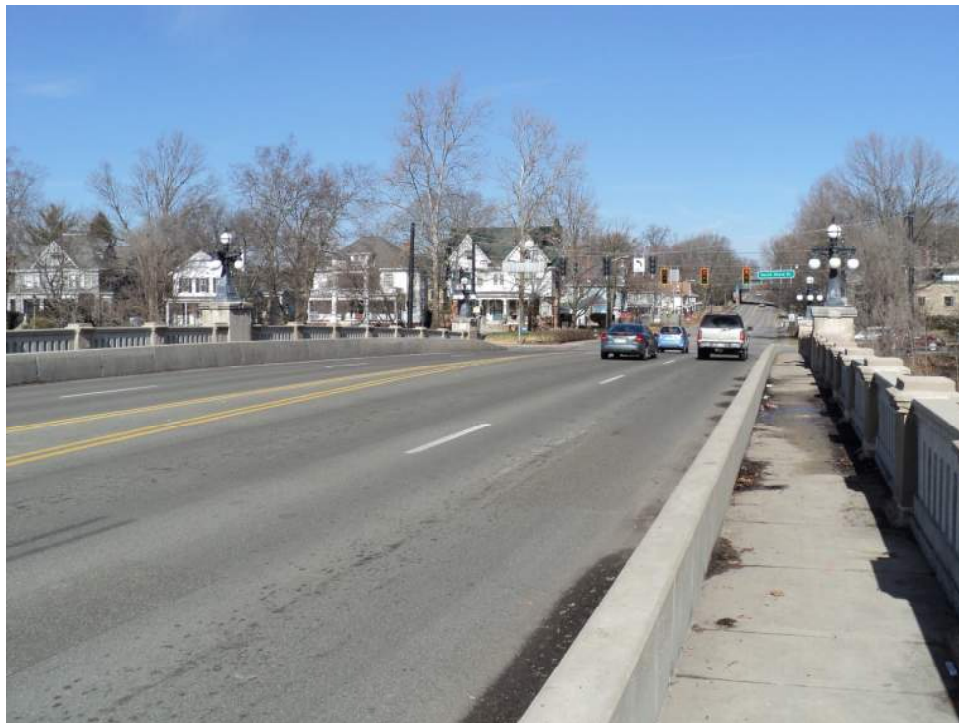
Description: Typical Existing Roadway Wearing Surface

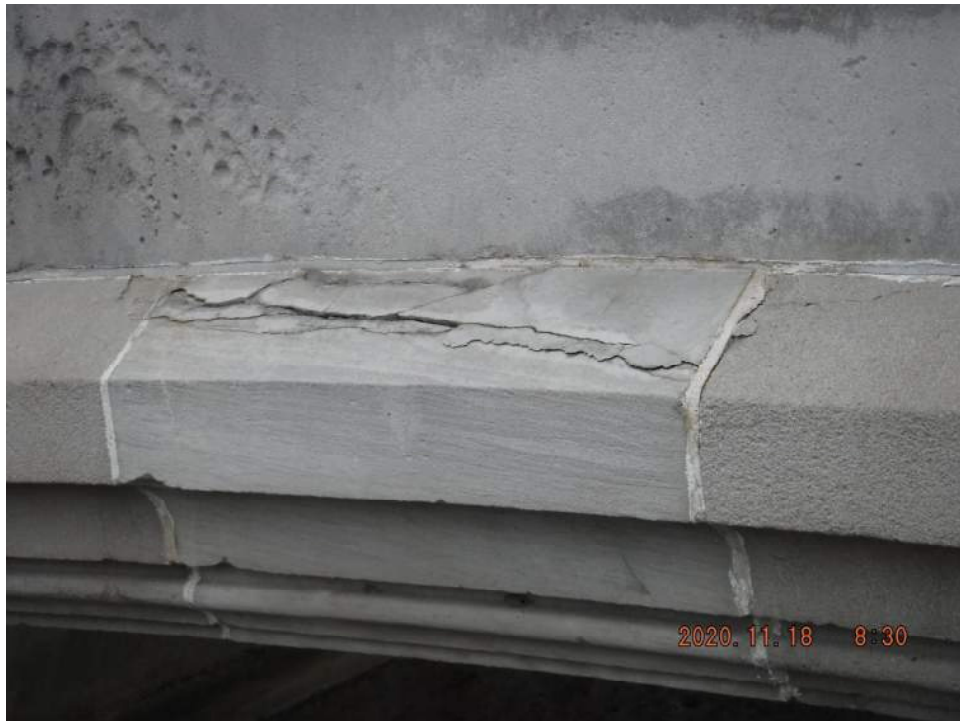
Description: Spalling of Limestone Block (Typ.)

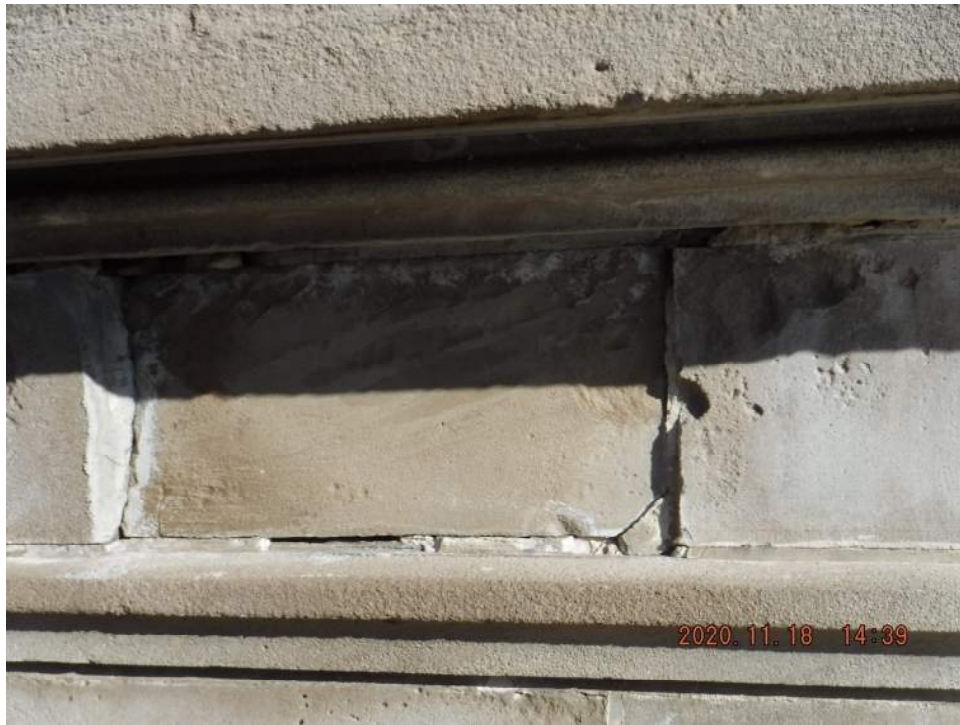
Photo 32

Description: Cracking of Limestone Block (Typ.)

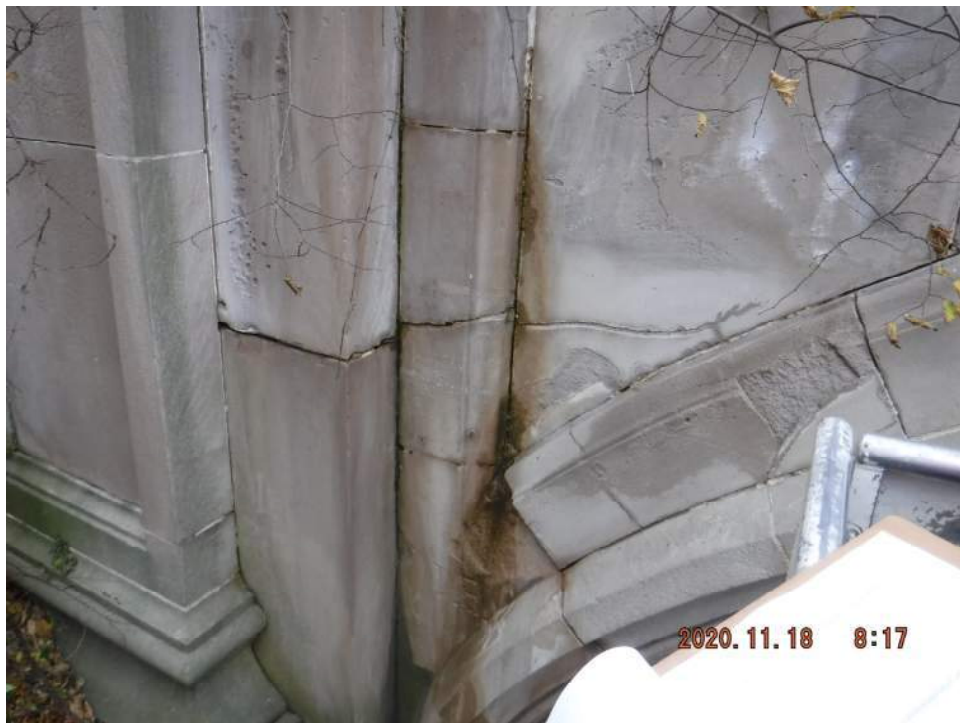
Photo 33

Description: Failing Grout at Joints between Limestone Blocks (Typ.)

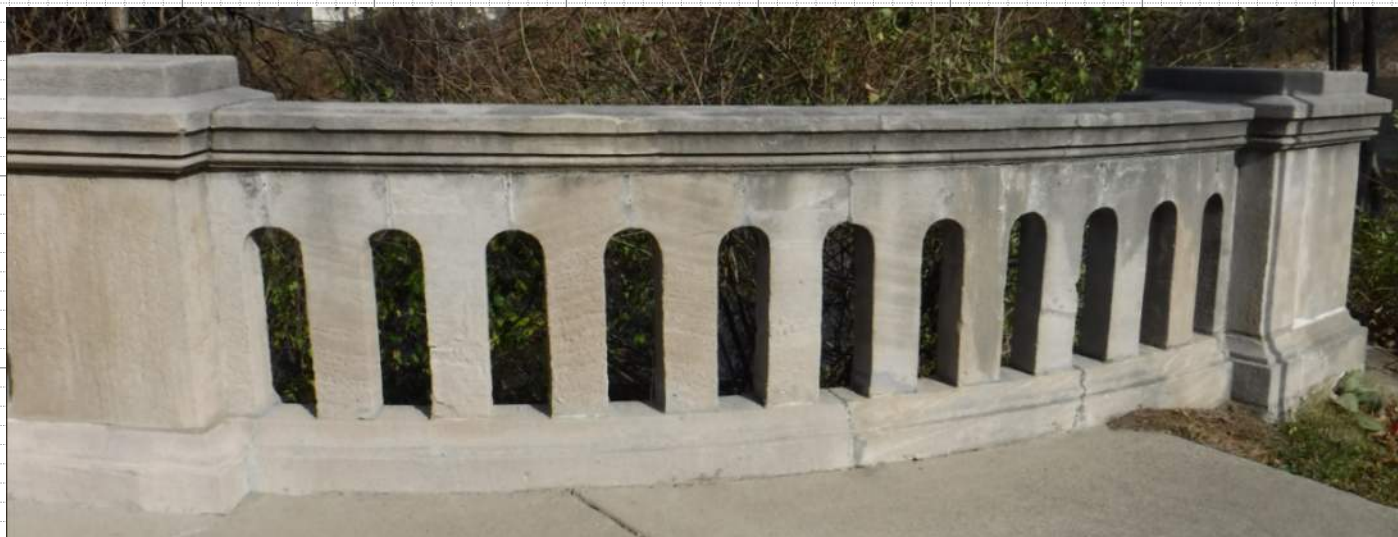
This remaining stone railing panel, at the south end of the east bridge railing, shows limited deterioration. This limited deterioration is believed to be due to its location further from the roadway than nearly all other railing panels, limiting the amount of salt spray and other roadside chemicals.

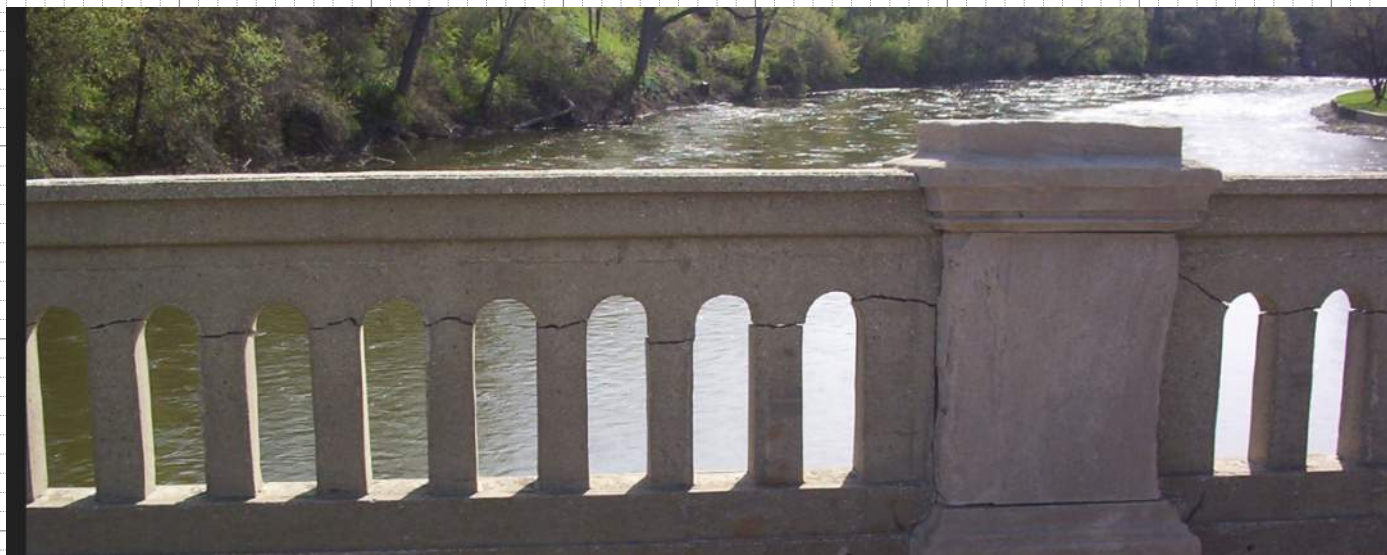
This is a typical concrete railing panel which was replaced in 2006; however note that the replacement was due to cracking, as visible above, due to settlement at the east end of Pier 3 and not due to deterioration of the railing.

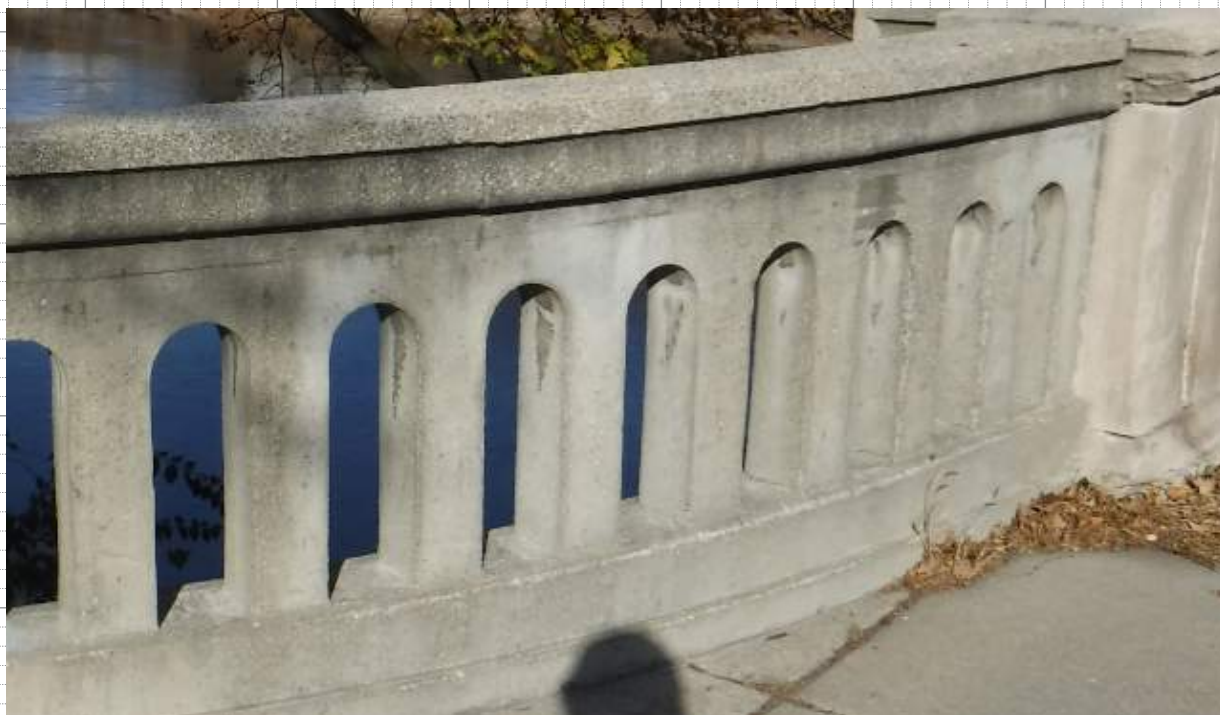
This is a typical concrete railing panel from the 1977 rehabilitation, which exhibit limited deterioration.

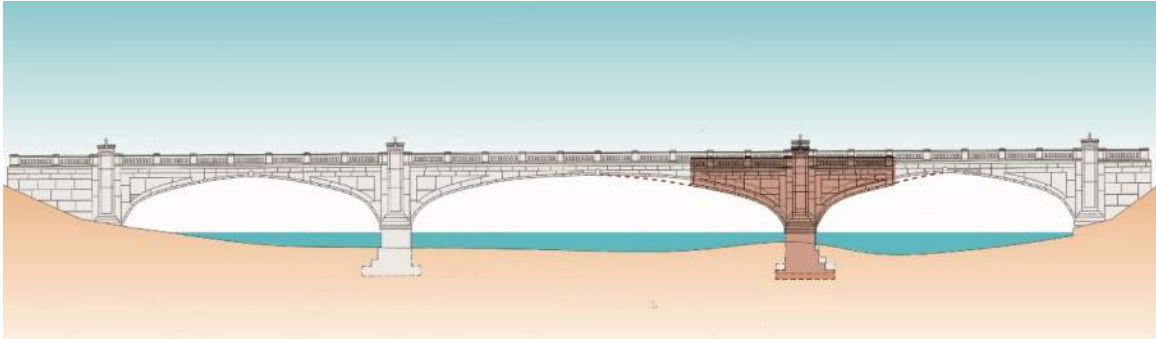
Arch Drop and Deflection Theory

- As illustrated by the figure below, it is believed that the undermining and scour at the upstream side of Pier No. 3, caused the pier to settle. This settlement corresponds to the drop in the arch segments in the pier. There has been little change in the differential of the arch segment drops since beginning the annual special inspections in 2013.

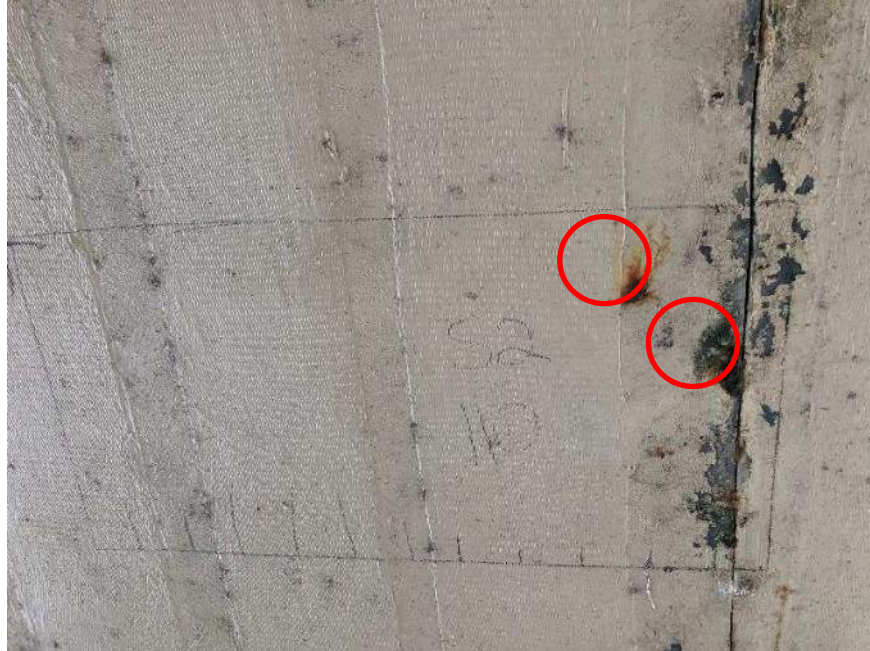
Rust staining and active seep, downstream center of Span B

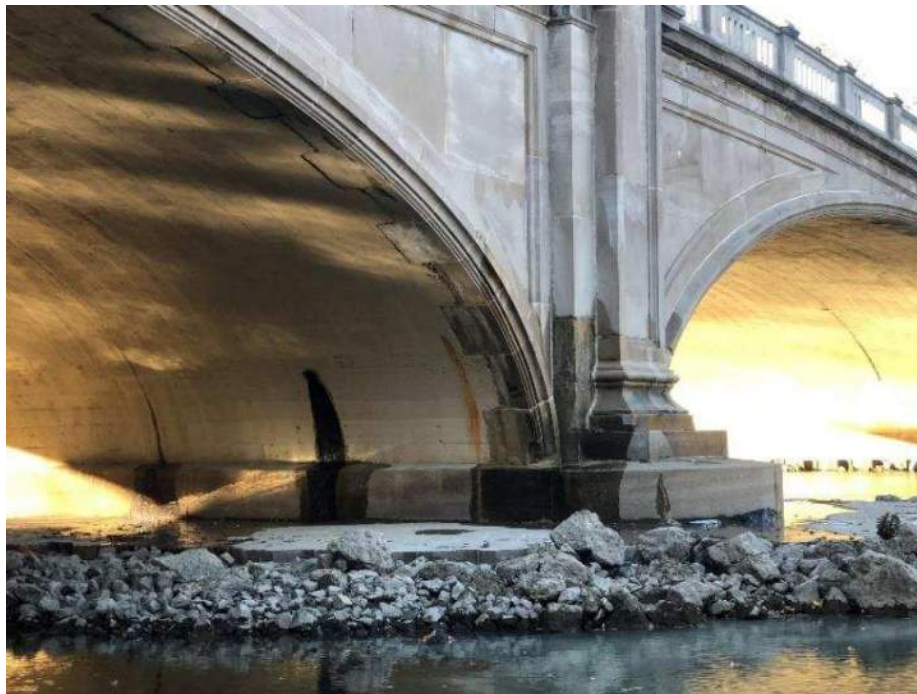
While performing Test Core TC-2 (through Pier 2), circulating water used in the coring process was observed exiting the eastern (upstream) drains on both sides of the pier, from several arch joints, and from joints on the upstream facade near the base of the pier as shown in the photographs below. The same phenomena was not readily apparent while performing Test Core TC-4 through Pier 3.

The south side of Pier 2 while performing Test Core TC-2.

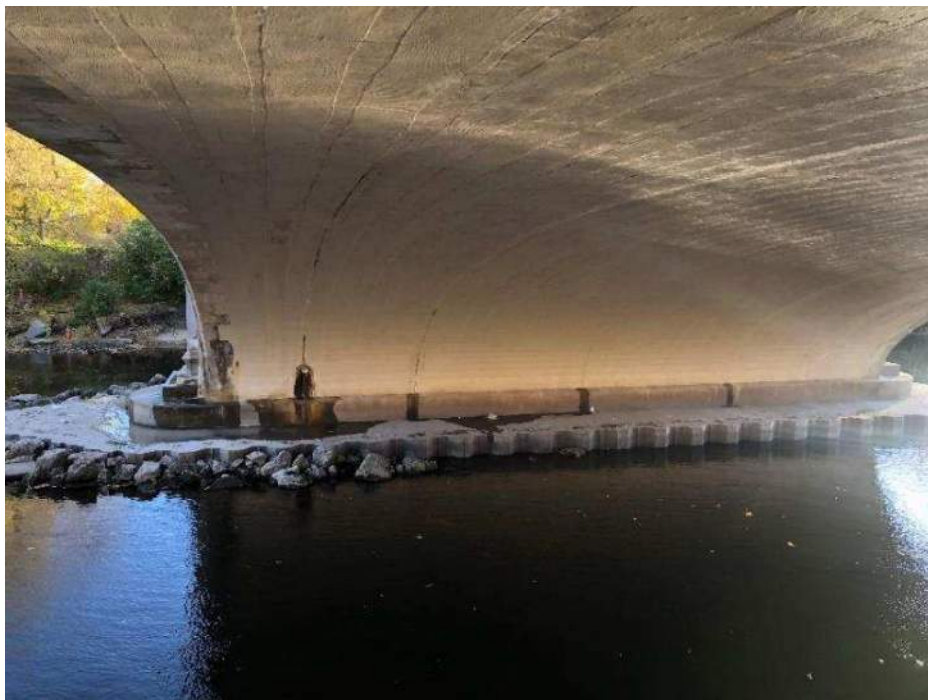
The north side of Pier 2 while performing Test Core TC-2. Water exiting the drain, arch joints and façade.

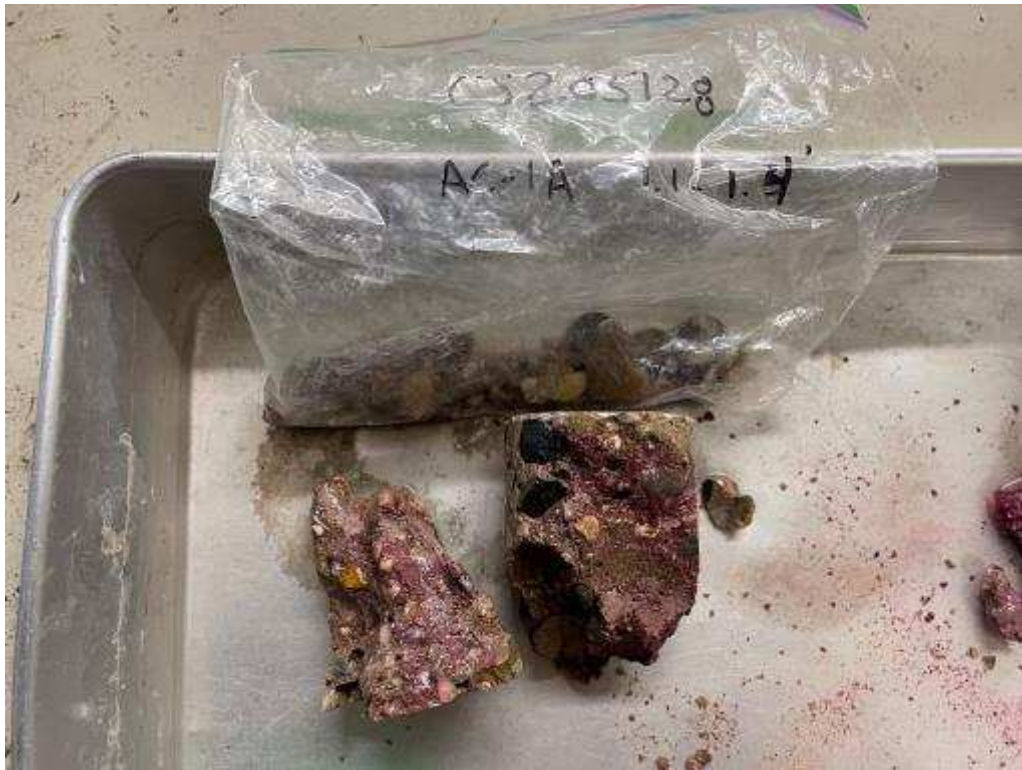
Photo 1: Broken surfaces of Core AC-1A (1.1'-1.4') after application of phenolphthalein stain. Areas not stained magenta are carbonated. No Carbonation apparent.

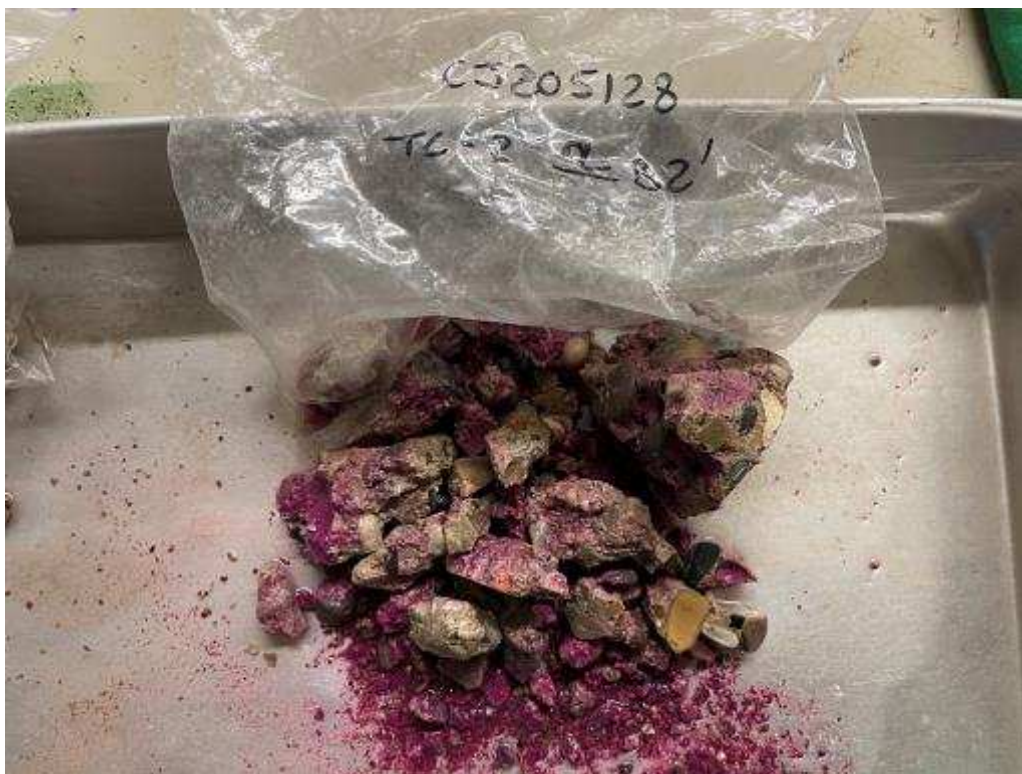
Photo 2: Broken surfaces of Core TC-2 (32') after application of phenolphthalein stain. Areas not stained magenta are carbonated. No Carbonation apparent.

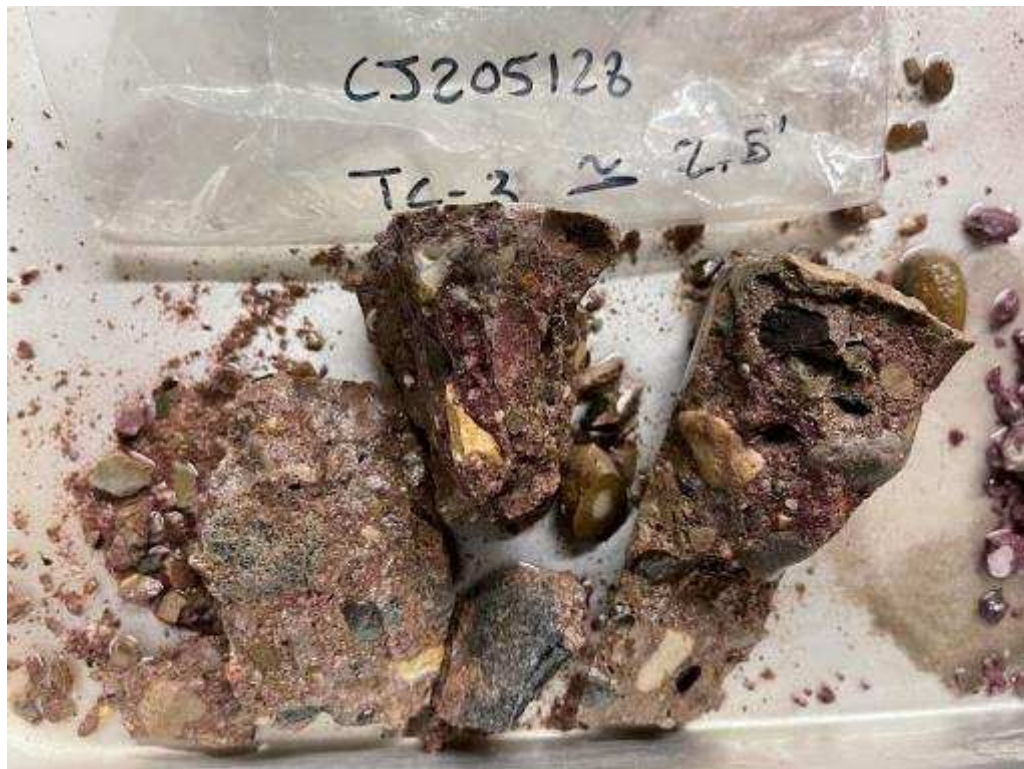
Photo 3: Broken surfaces of Core TC-3 (2.5') after application of phenolphthalein stain. Areas not stained magenta are carbonated. No Carbonation apparent.

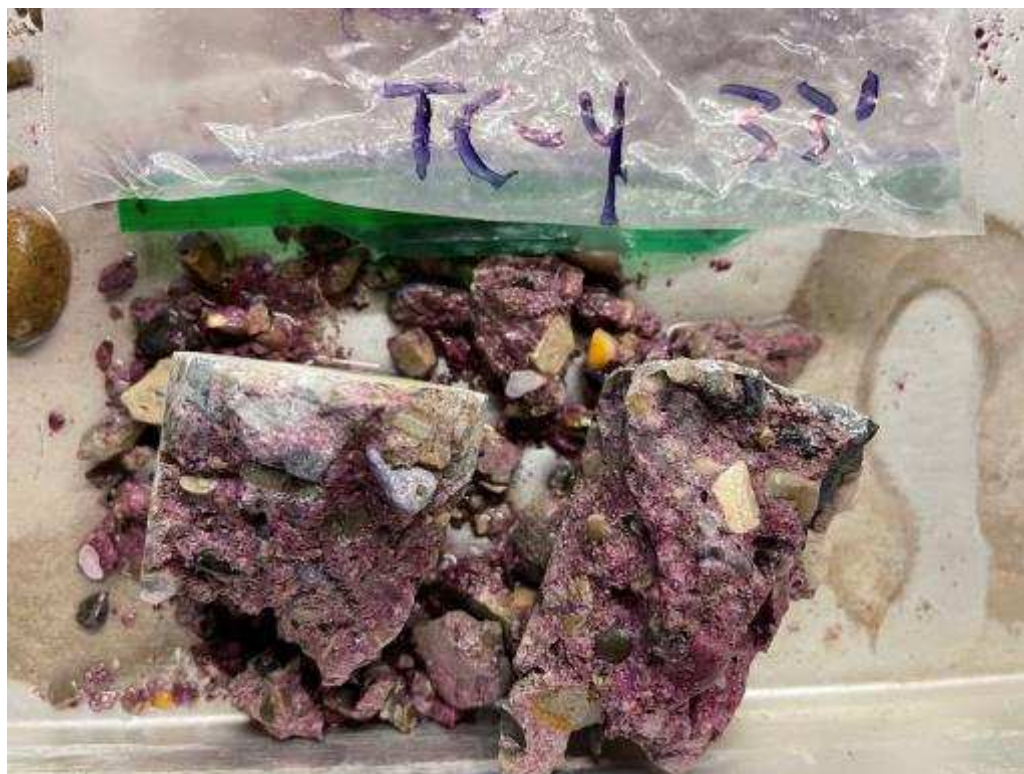
Photo 4: Broken surfaces of Core TC-4 (33') after application of phenolphthalein stain. Areas not stained magenta are carbonated. No Carbonation apparent.
