Historic Bridge Alternatives Analysis

BRIDGE NUMBER: (933)31-71-03690 E

ROUTE IDENTIFICATION AND FEATURE CROSSED:
SR 933 over St. Joseph River

PREPARED BY: Adam Steury, PE, SE
Lochmueller Group, Inc.

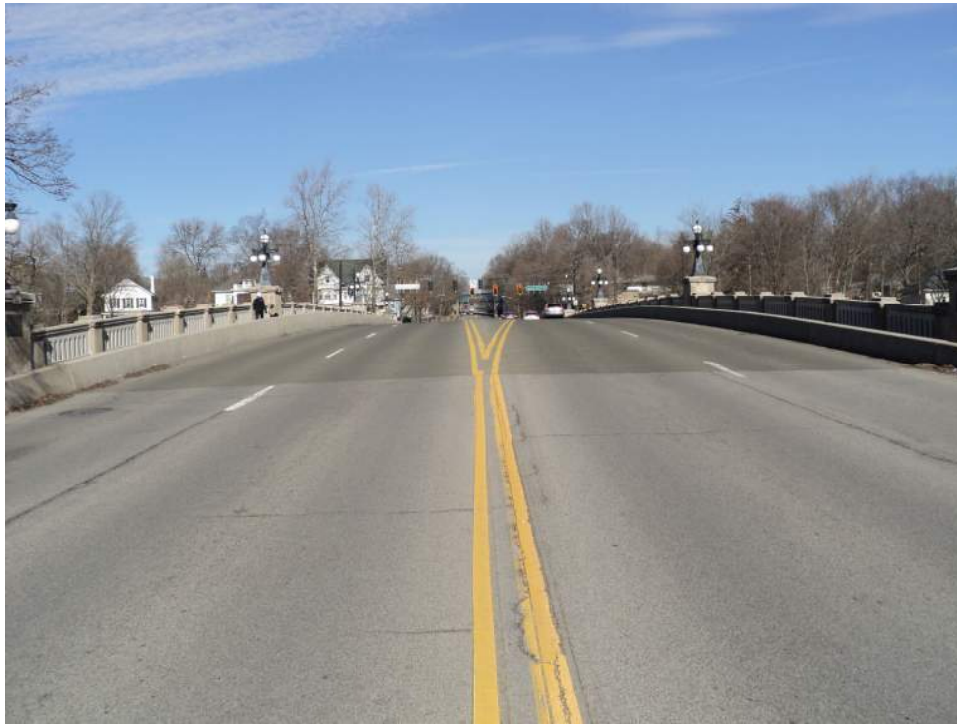
Photo 1

Vantage Point: South of Bridge
Direction: Looking North
Description: South Approach

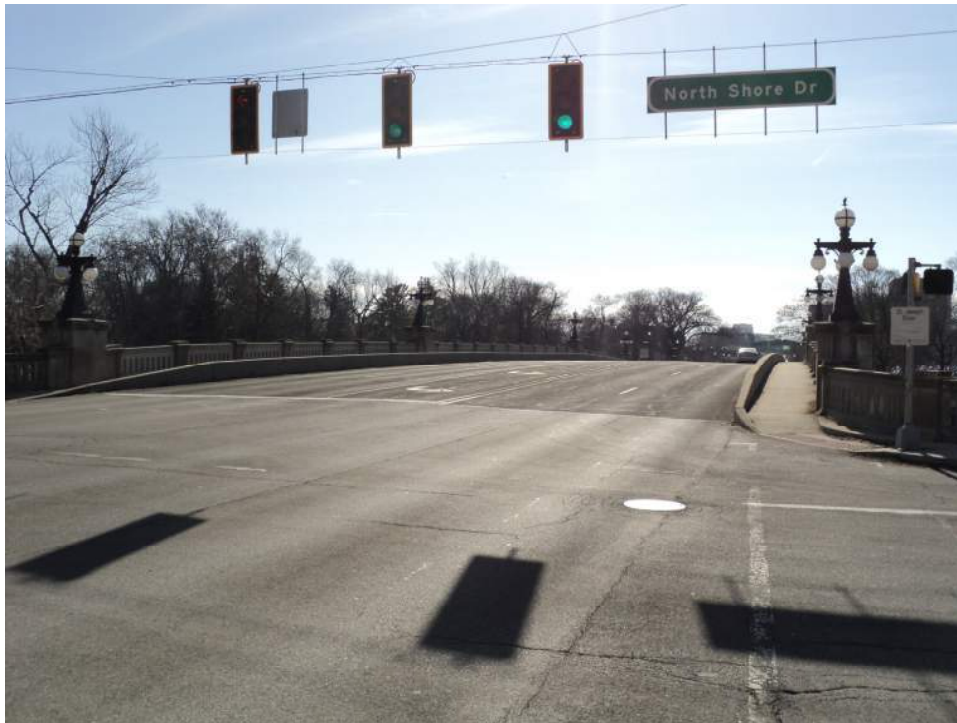
Photo 2

Vantage Point: Northwest of Bridge
Direction: Looking Southeast
Description: North Approach

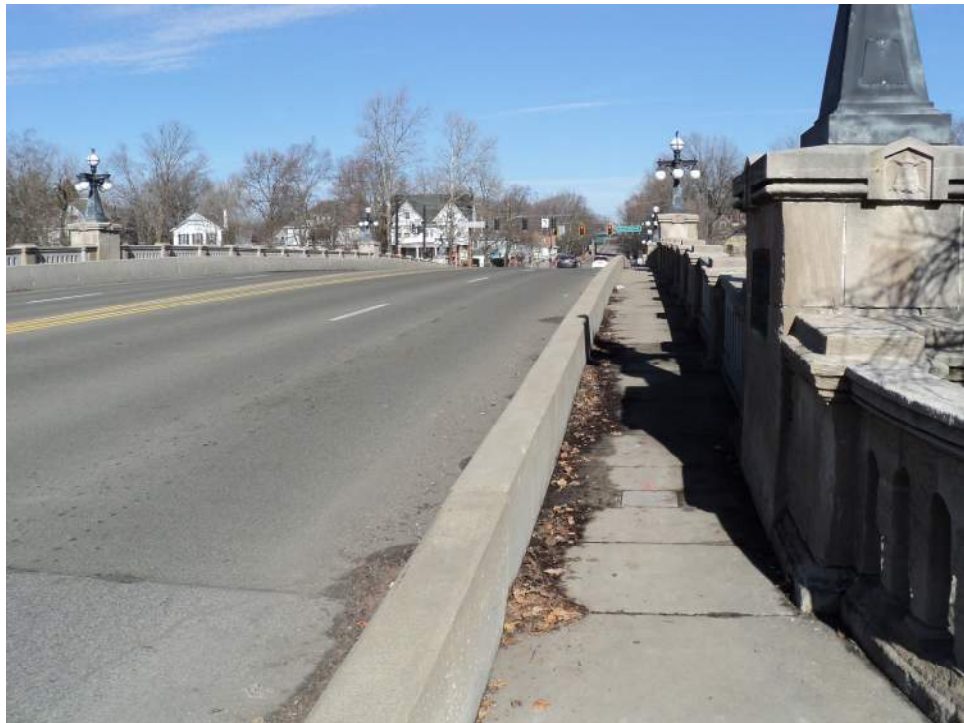
Photo 6

- Curbs: The barrier curb between the roadway and sidewalk is in good condition with vertical cracking at approximately 2'-0" spacing. There is no visual indication of collision damage on the barrier curb.
- Sidewalks: The sidewalks are both in good condition with minor transverse cracking present.

Description: East Sidewalk, Barrier Curb, and Railing

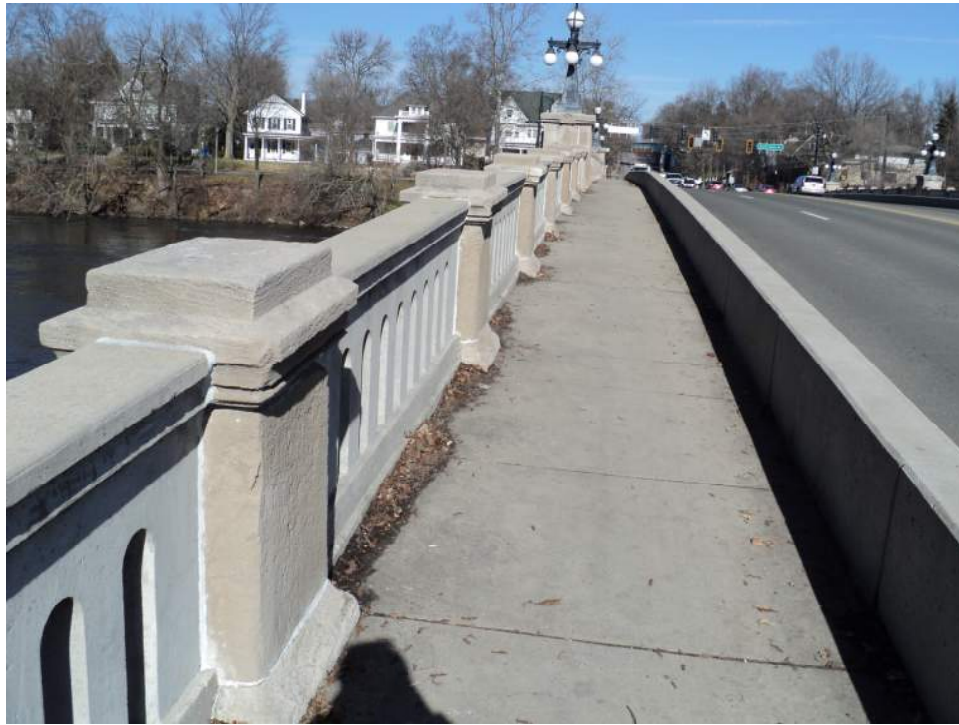
Photo 7

Description: West Sidewalk, Barrier Curb, and Railing

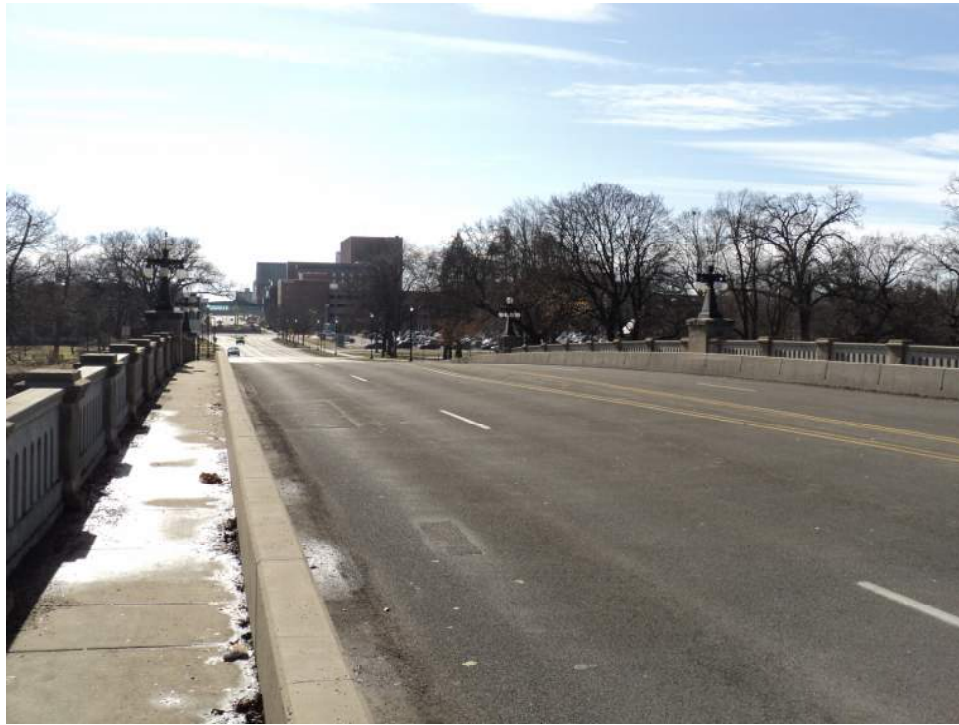
Photo 9

- Overlay: There is a Polymeric Concrete Overlay on the bridge.
- Surface Condition: The condition of Polymeric Concrete Overlay wearing surface is "fair" (Condition Rating 5 out of 9). Widely spaced transverse cracks intersecting with a single longitudinal crack are present in the northbound lane of the south and main spans.

Description: Typical Existing Roadway Wearing Surface

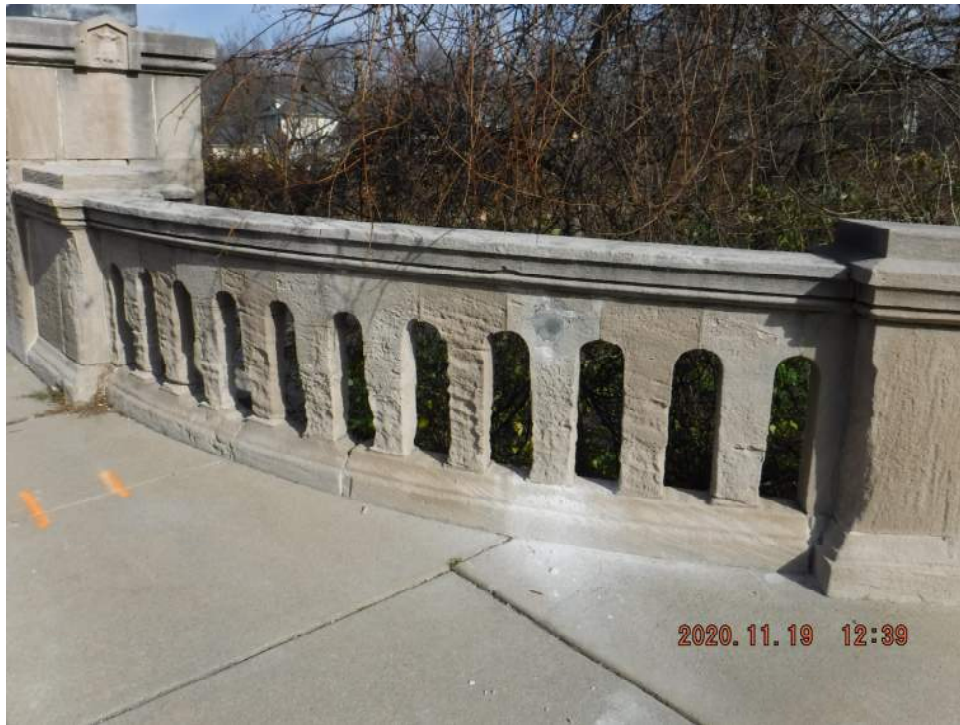
Photo 19

- Bridge Railing: The concrete railing is in good condition with minor cracking and weathering. Two panels of original limestone railing are present at the southeast corner of the bridge; the northernmost panel has

moderate weathering while the southernmost panel has negligible deficiencies. Limestone pilasters are present between railing panels at approximately 15'-0" spacing and are in fair condition with minor cracking, spalling, and weathering.

Description: Original Limestone Railing (Second Railing Panel from South)

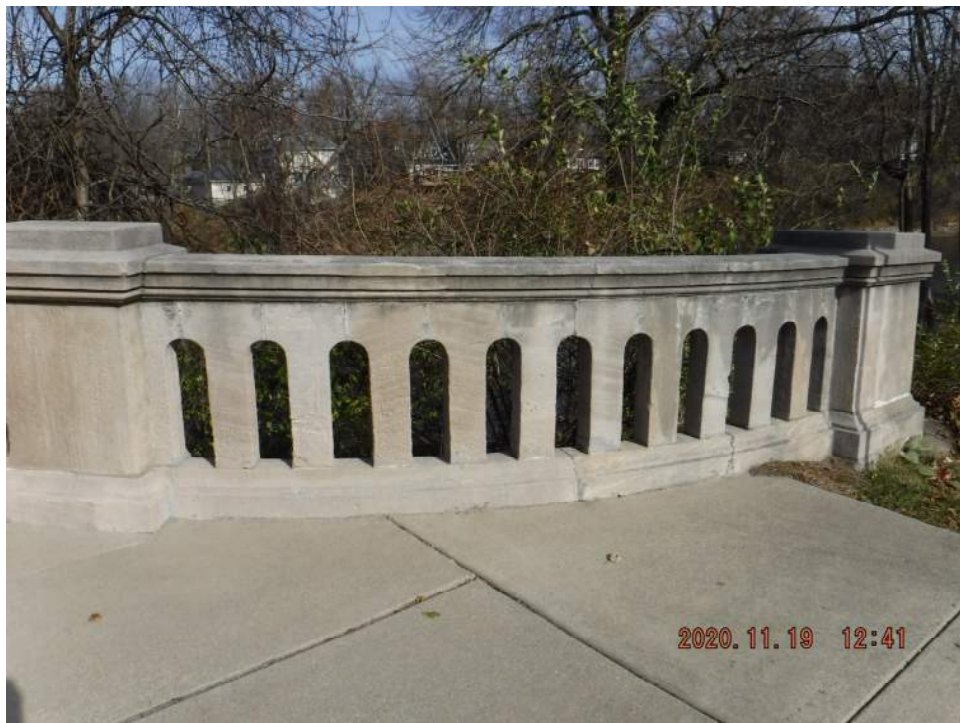
Photo 20

Description: Original Limestone Railing (First Railing Panel from South)

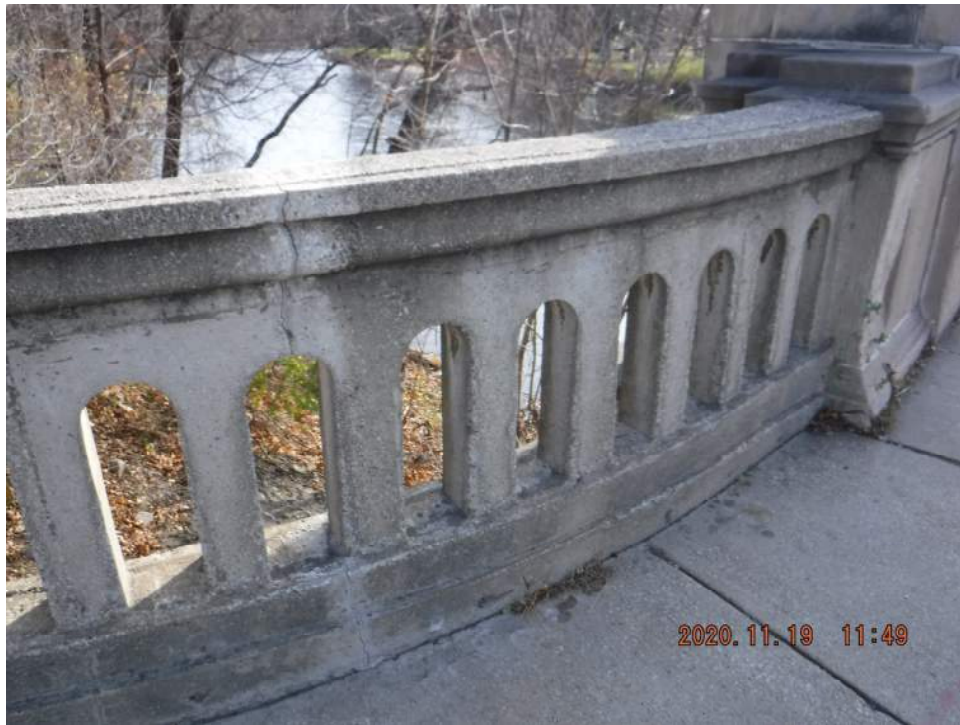
Photo 21

Description: Concrete Railing from Rehabilitation Prior to 2006 (Typ.)

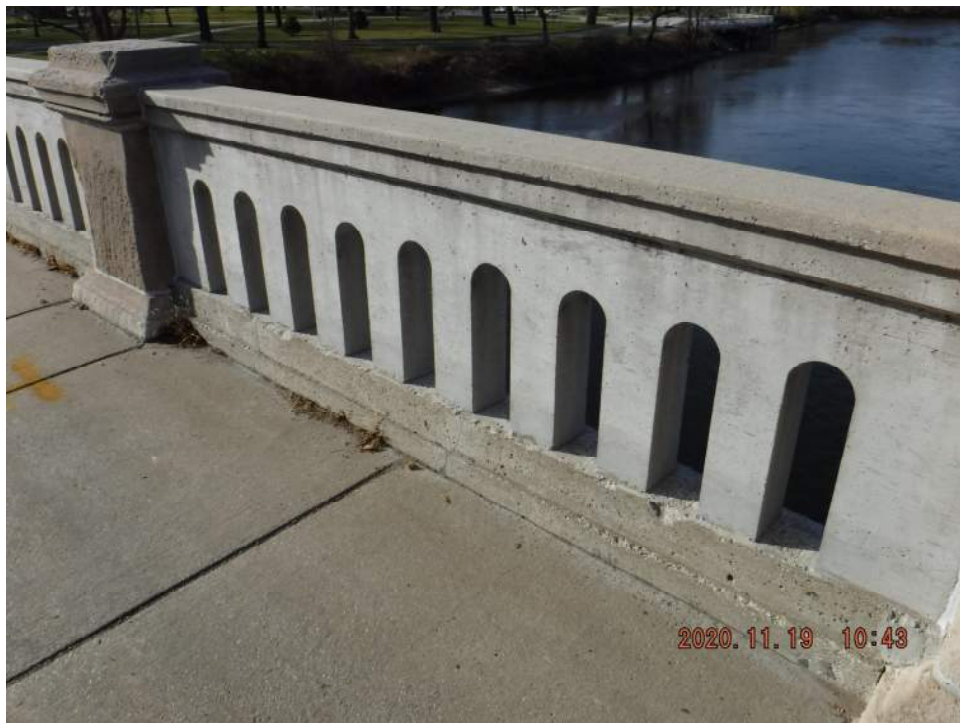
Photo 22

Description: Concrete Railing from 2012 Rehabilitation (Typ.)

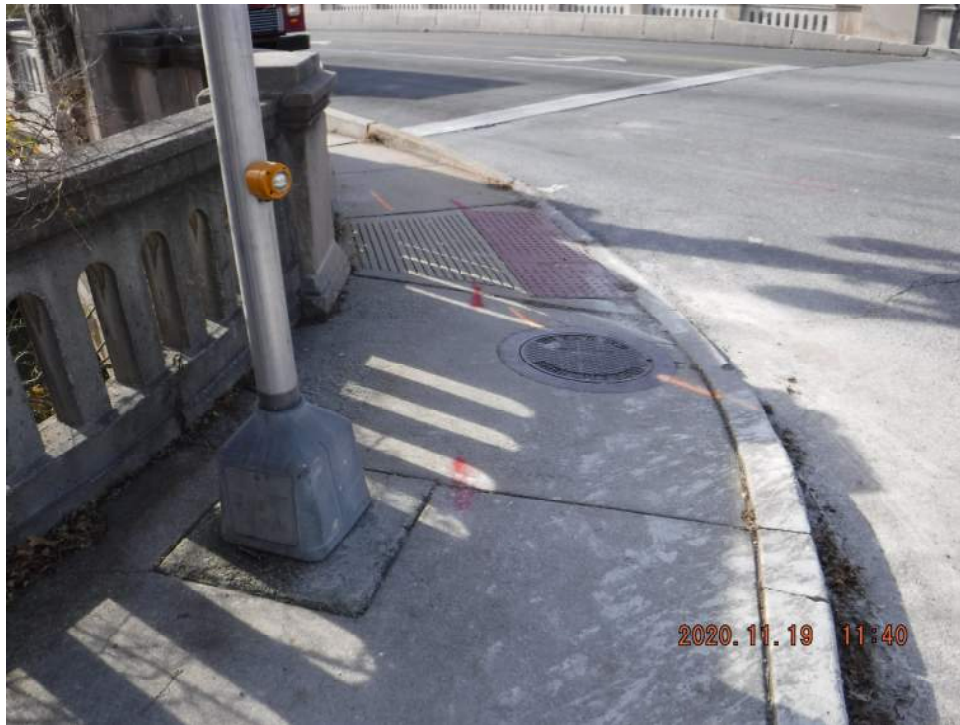
Photo 23

- General: The asphalt approach pavement overall is in good condition. Minor cracking and rutting is present in the approach pavement. Curb ramps meeting current standards are present near the north end of the bridge at the intersection of SR 933 and North Shore Drive.

Description: Curb Ramp at Intersection with North Shore Drive

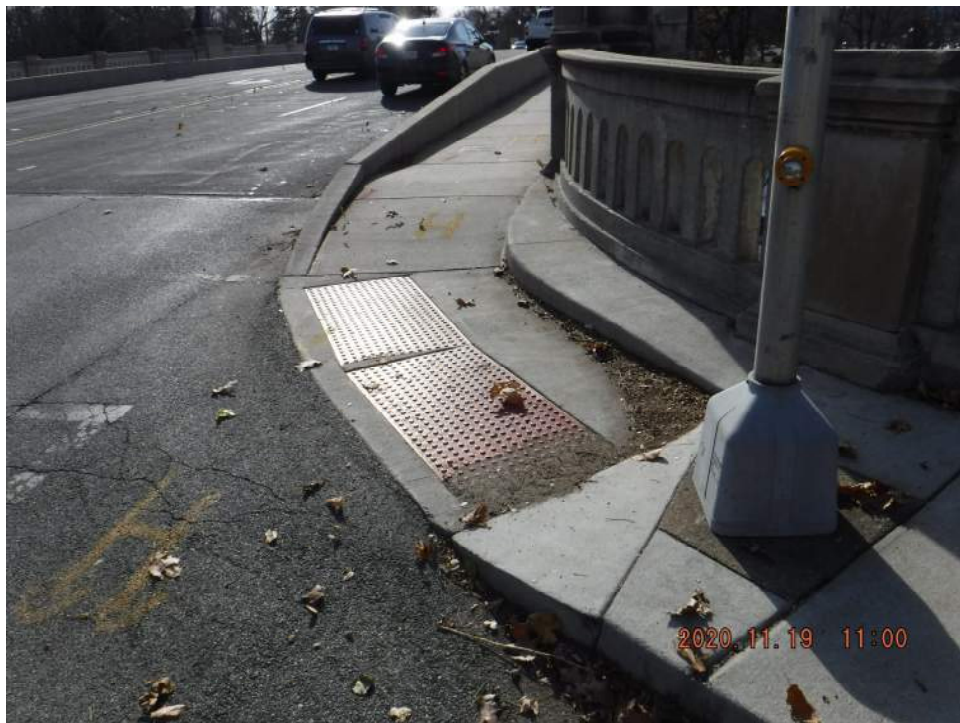
Photo 24

Description: Curb Ramp at Intersection with North Shore Drive

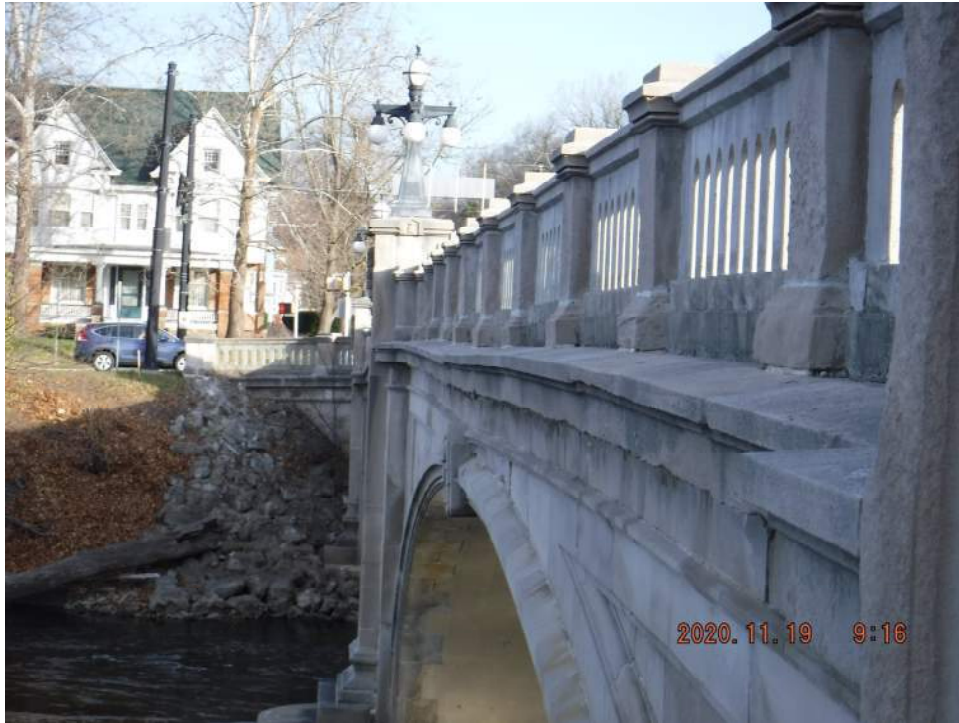
Photo 25

- General: The overall condition of the substructure is "fair" (Condition Rating 5 out of 9). Limestone weathering and concrete deterioration is present at all substructure units.
- Scour & Settlement: Settlement is present at the east end of Pier 3. This settlement is believed to have been due to previous scour and footing undermining that was initially stabilized with riprap and later with a concrete filled cofferdam around the piers.

Description: Sag in Limestone Coping Blocks at Middle of Span B

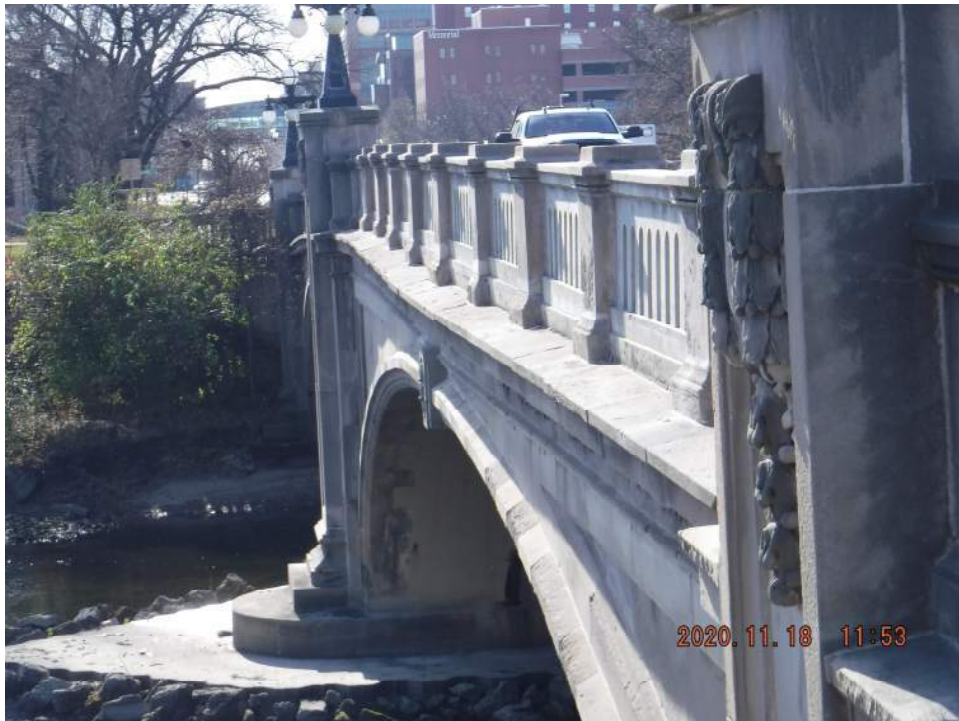
Photo 26

Description: Sag in Limestone Coping Blocks at Middle of Span B

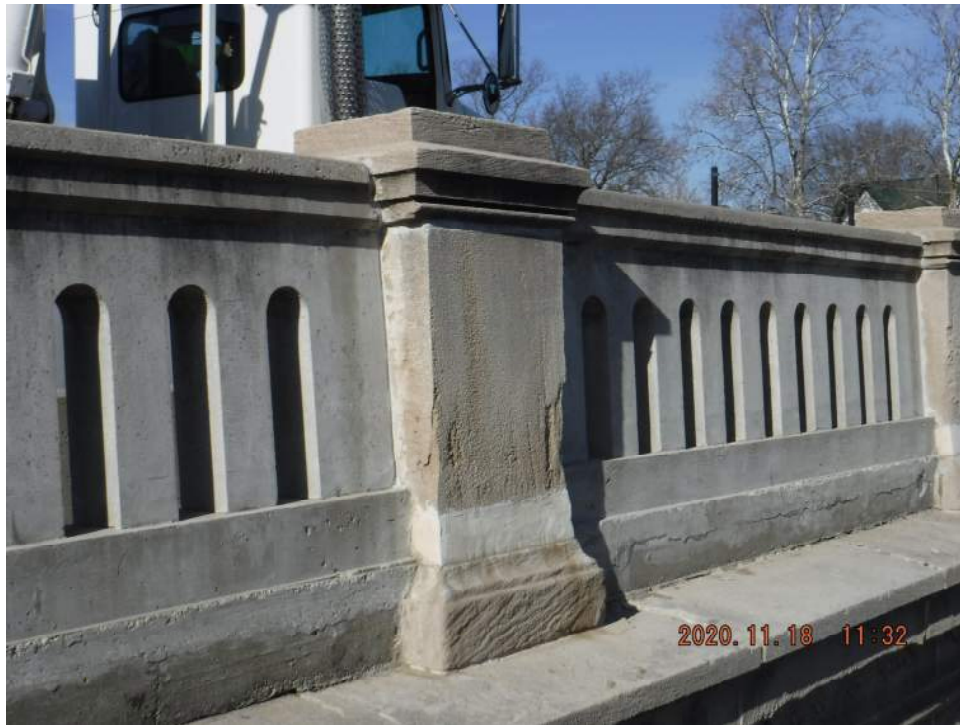
Photo 27

Description: Patched Gap in Railing Pilaster

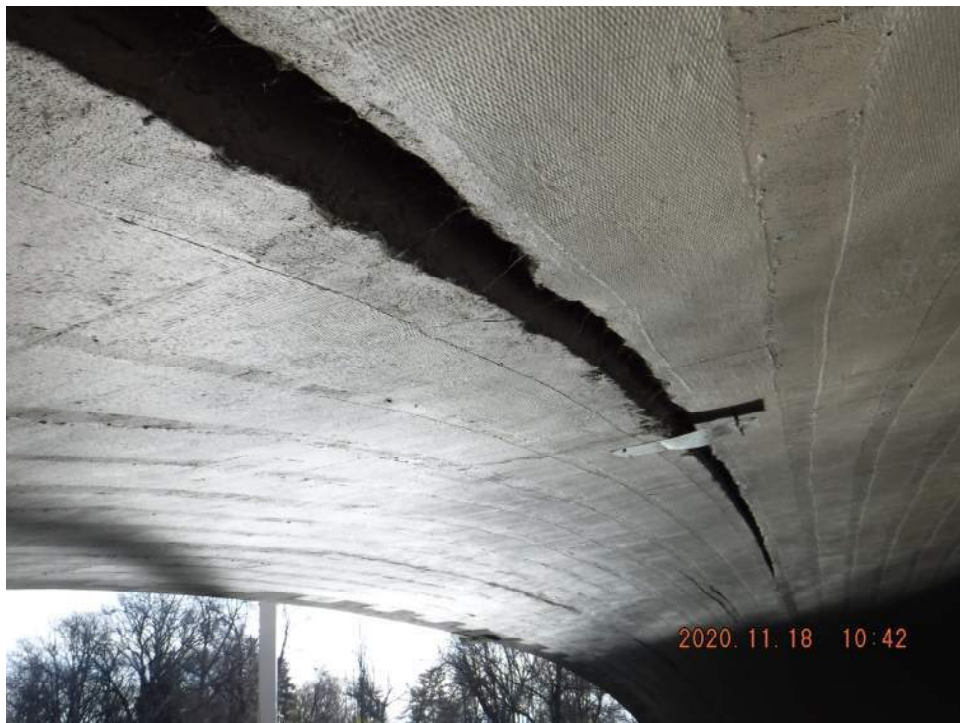
Photo 28

- Arches: The arches (underside of the bridge) are in fair condition. Each span consists of four (Spans A & C) or six (Span B) separate conventionally reinforced concrete, directly adjacent, arch ring segments which are tied together with minimal reinforcement. Fiber reinforced polymer strips on the underside of the arches in all spans exhibit air pockets and debonding between the strip and the concrete surface in many locations with some locations peeling off. Differential settlement between the exterior and first interior arch ring segments of Spans B and C is present on the east (upstream) side of the bridge. This differential settlement between arches is a maximum of approximately 3" in the main span and 2" in the north span. Settlement of the east end of Pier 3 (north pier) is believed to have caused this differential arch settlement; please see substructure conditions below for further explanation.

Description: Arch Separation

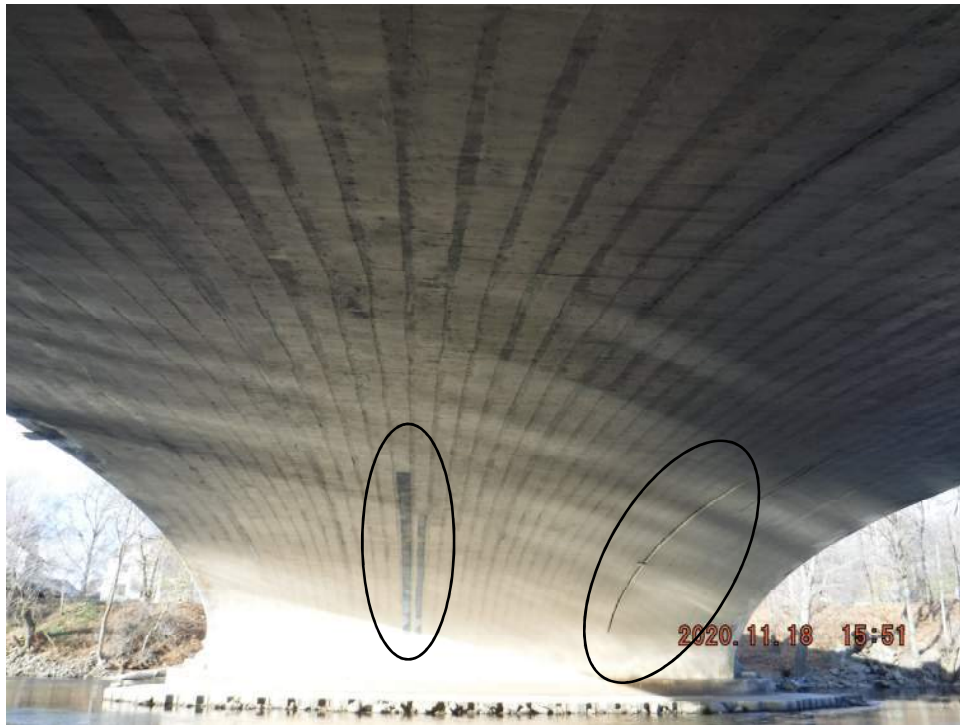
Photo 29

Description: Fiber Reinforced Polymer Fallen Off and Arch Separation

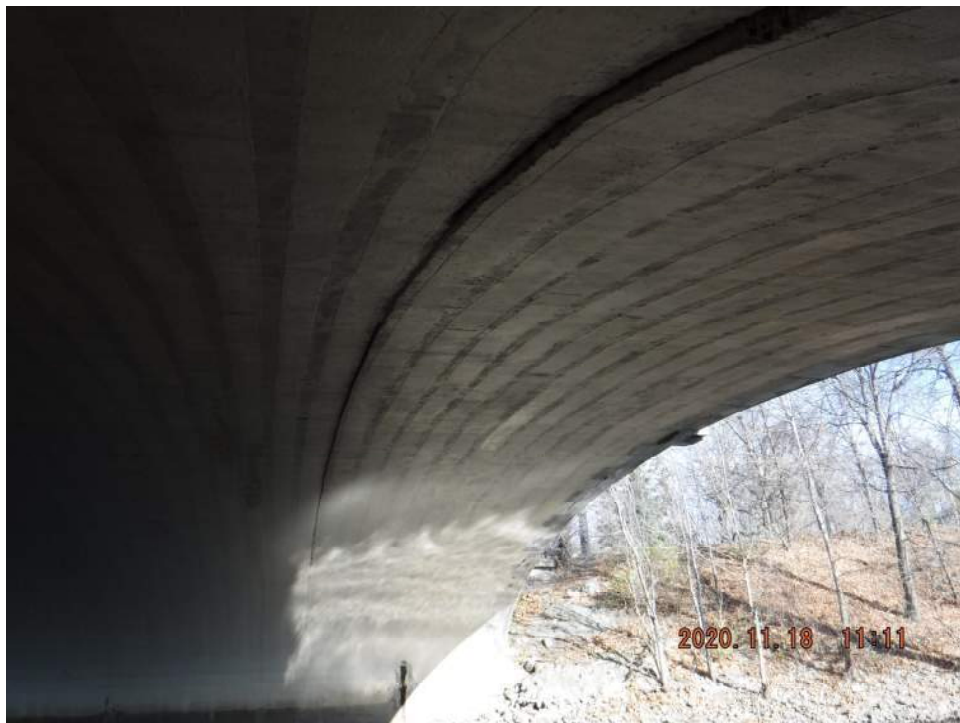
Photo 30

Description: Arch Separation

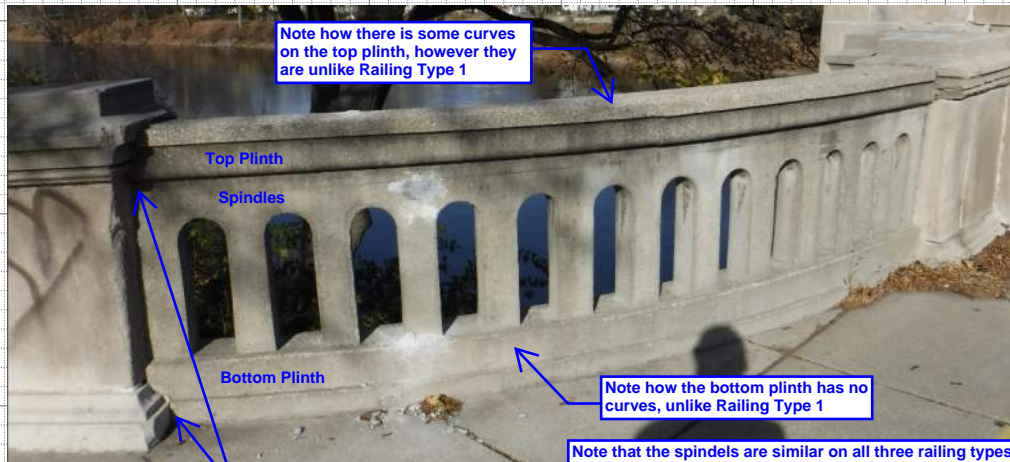
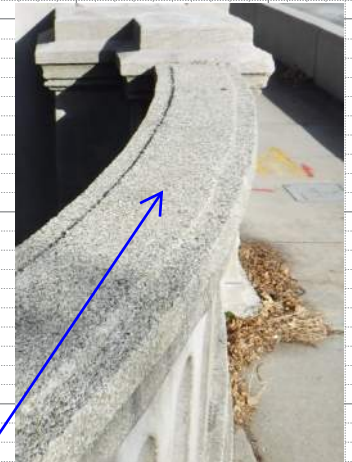
Railing Type 2 - Concrete Railing at Corners

There are six panels of this concrete railing remaining on the bridge, they are located at the southwest, northwest, and northeast corners of the bridge at the end of the railing. Please see below for specific aesthetics of this railing and its comparison to the Railing Type 1 (original).

Note how the shape of the top and bottom plinths do not match the pedestals, unlike Railing Type 1

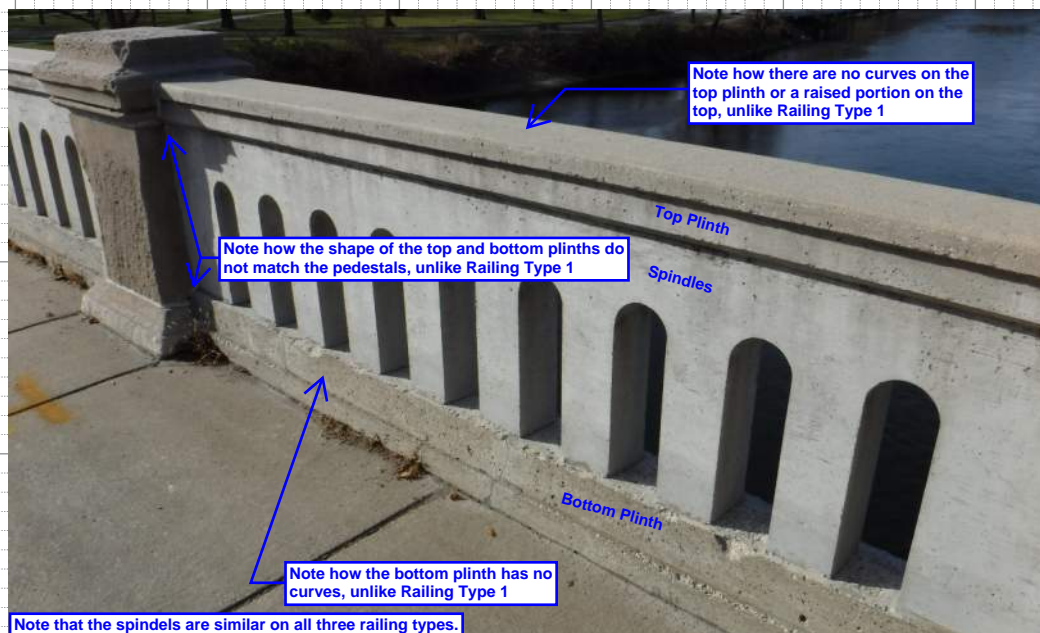
Railing Type 3 - Concrete Railing Elsewhere

All remaining railing panels which are not Type 1 or 2 are this Type 3 concrete railing. Please see below for specific aesthetics of this railing and its comparison to the Railing Type 1 (original).

Note that it is recommended on this project that all railing replaced be concrete and match the details from the 1945 Rehabilitation Plans to match the shape of the original stone railing.

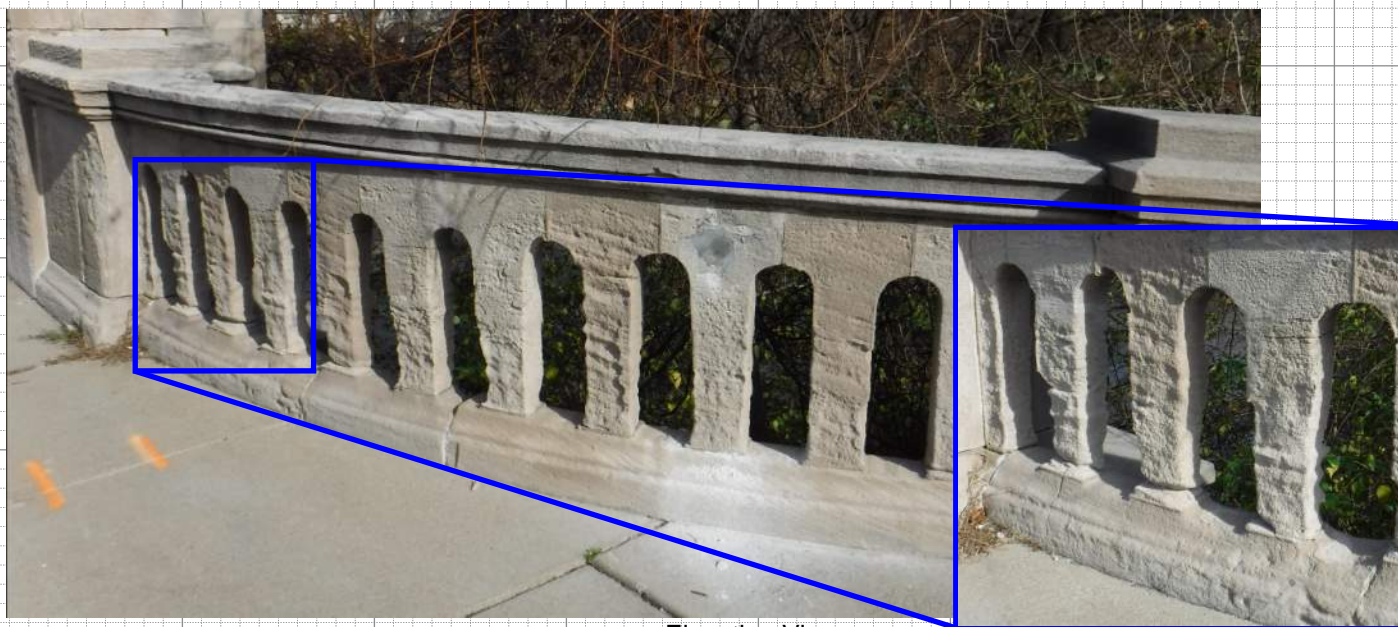
Elevation View

This remaining stone railing panel, second panel from the south end of the east bridge railing, shows typical deterioration experienced by stone railing on this bridge. This deterioration is the reason only this and the above stone panel remain on the bridge.

Due to the continued replacement of stone railing on this bridge due to deterioration it is recommended that concrete railing be used to replace all existing concrete railing with the two existing stone railing panels be removed and reinstalled.

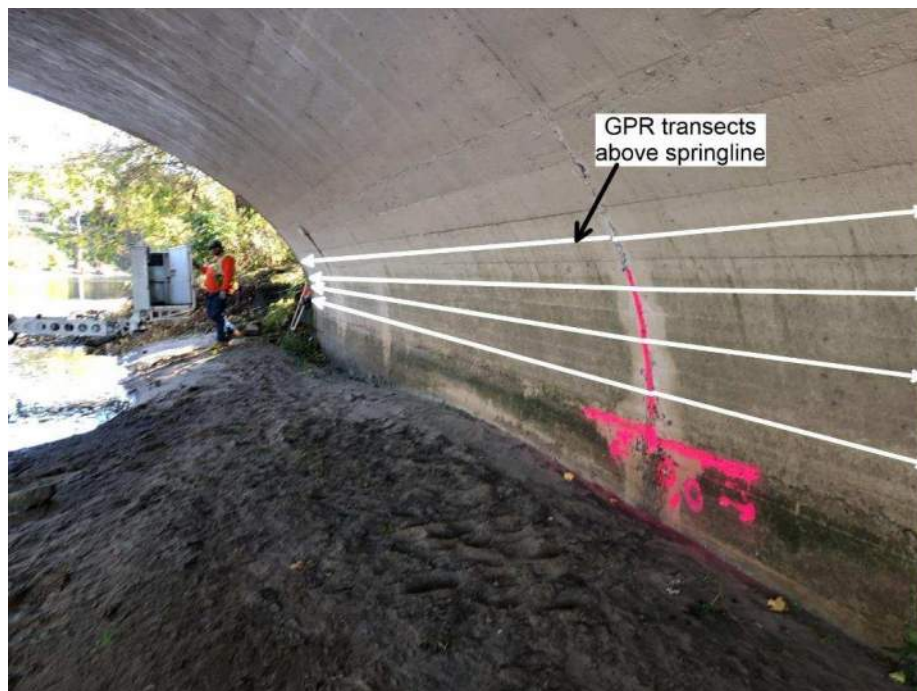
GPR Images – Span A

GPR lines were collected from the center (longitudinal) construction joint of each span to the east and west facades between the reinforcing strips, from about 7 ft above the spring line to the spring line. Longitudinal reinforcement bar spacing observed in these GPR transects was consistent with the rebar locator observations. The concrete cover thickness was consistently observed to increase as the longitudinal reinforcement approached the spring line. The longitudinal reinforcement became out of range approximately 1 to 2 ft above the spring line, as illustrated by the series of images below from Span A. The images below are from parallel lines collected from the center joint of Span A towards the west façade. The yellow markers represent reinforcement bars.

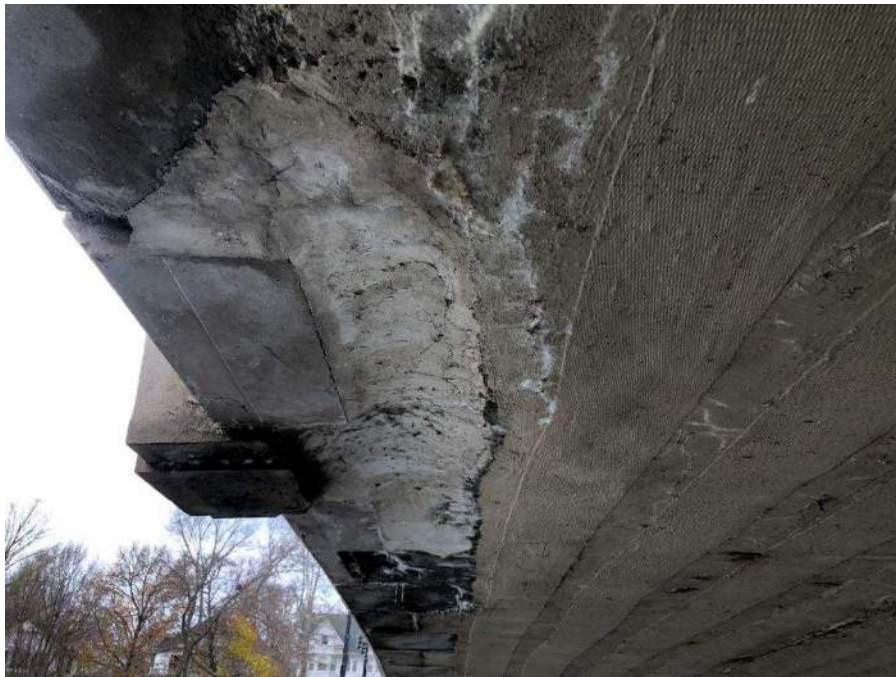
Mineral crystallization, downstream center of Span B

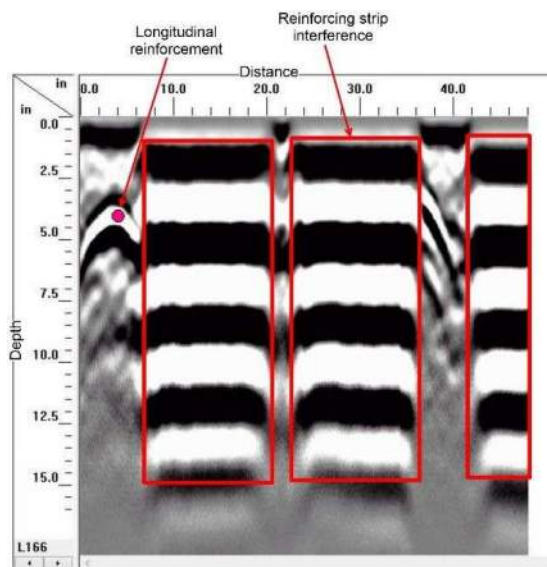
Data example from east-west line

Zones of potential deterioration within the arch and reinforcement locations are presented on Exhibits 2, 3, and 4. Areas of delamination/potential deterioration within the effective range of the GPR appear to be concentrated on the downstream portion near mid-span of Span B. Zones of deterioration were not observed in the GPR data collected on Spans A and C. These observations are generally consistent with previously-made observations.

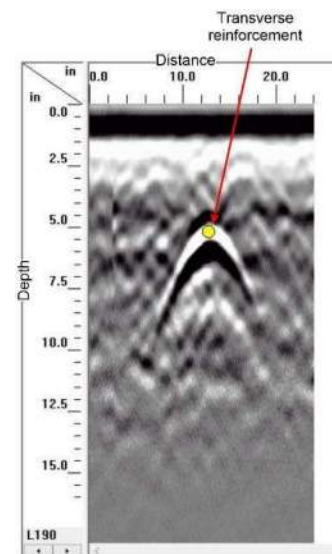
Data example from north-south line

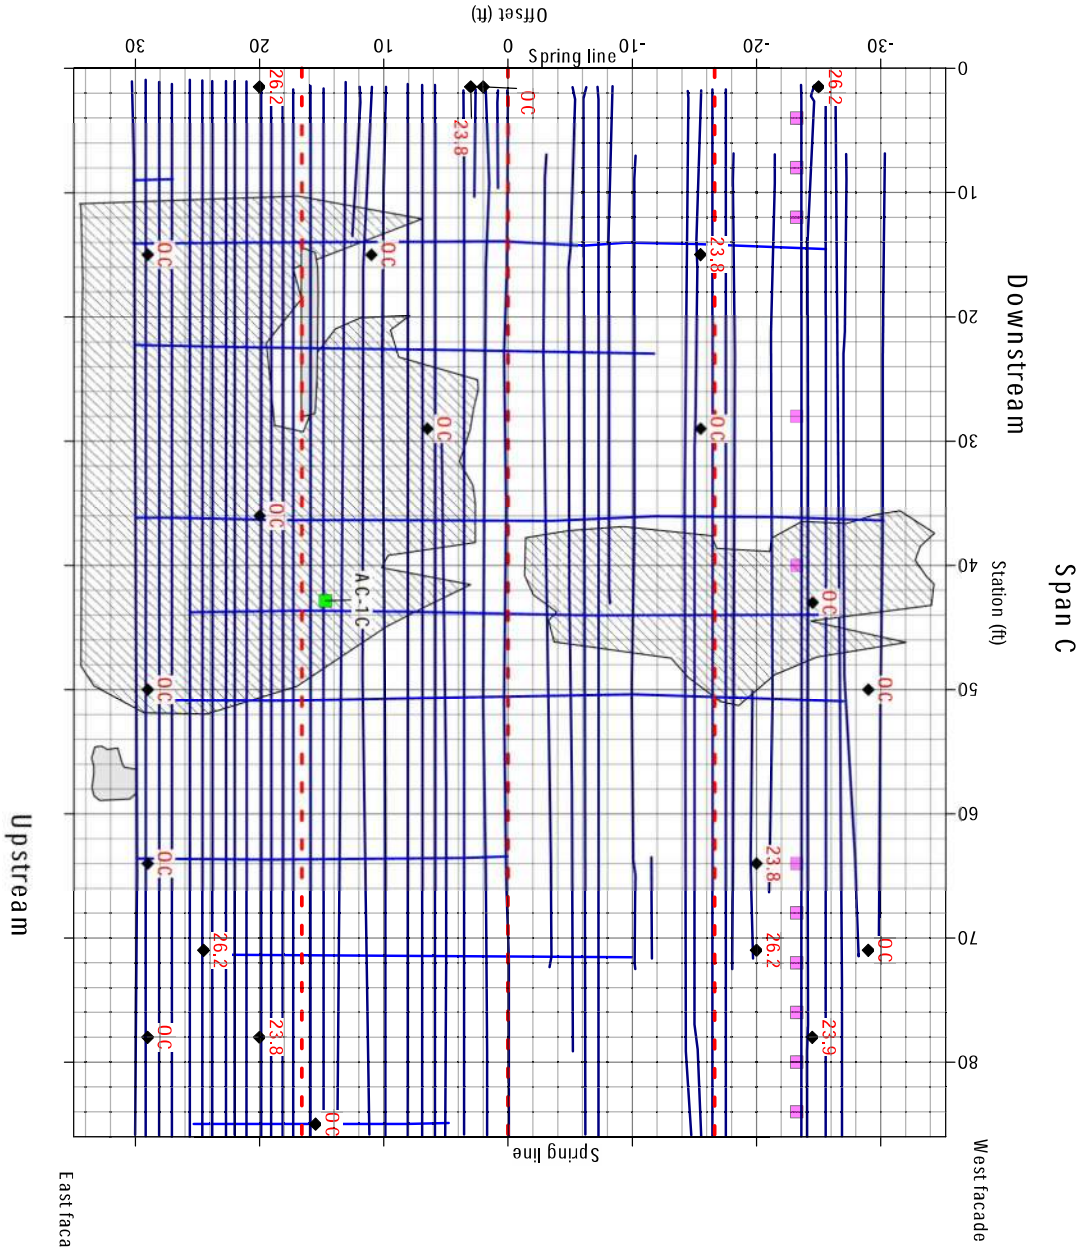
Additional Notes:
The reinforcement illustrated on this drawing represents observations from the GPR survey only. Please refer to *Non-Destructive Testing Observations* section in the memo for additional information.
IE observations were made over the entire span. The IE points illustrated on the drawing represent areas where honeycombing or delamination was identified. Please refer to the *Impact Echo Survey* in the memo for additional information.
